Spot Safety Project Evaluation

Spot Safety Project # 02-94-216

**Spot Safety Project Evaluation, of the Directional Crossover Installation and Geometric Revisions,
At the Intersection of US 264-Greenville Blvd and SR 1523-Whichard Road,
Near Greenville, in Pitt County**

Safety Evaluation Group
Traffic Safety Systems Management Section
Traffic Engineering and Safety Systems Branch
North Carolina Department of Transportation

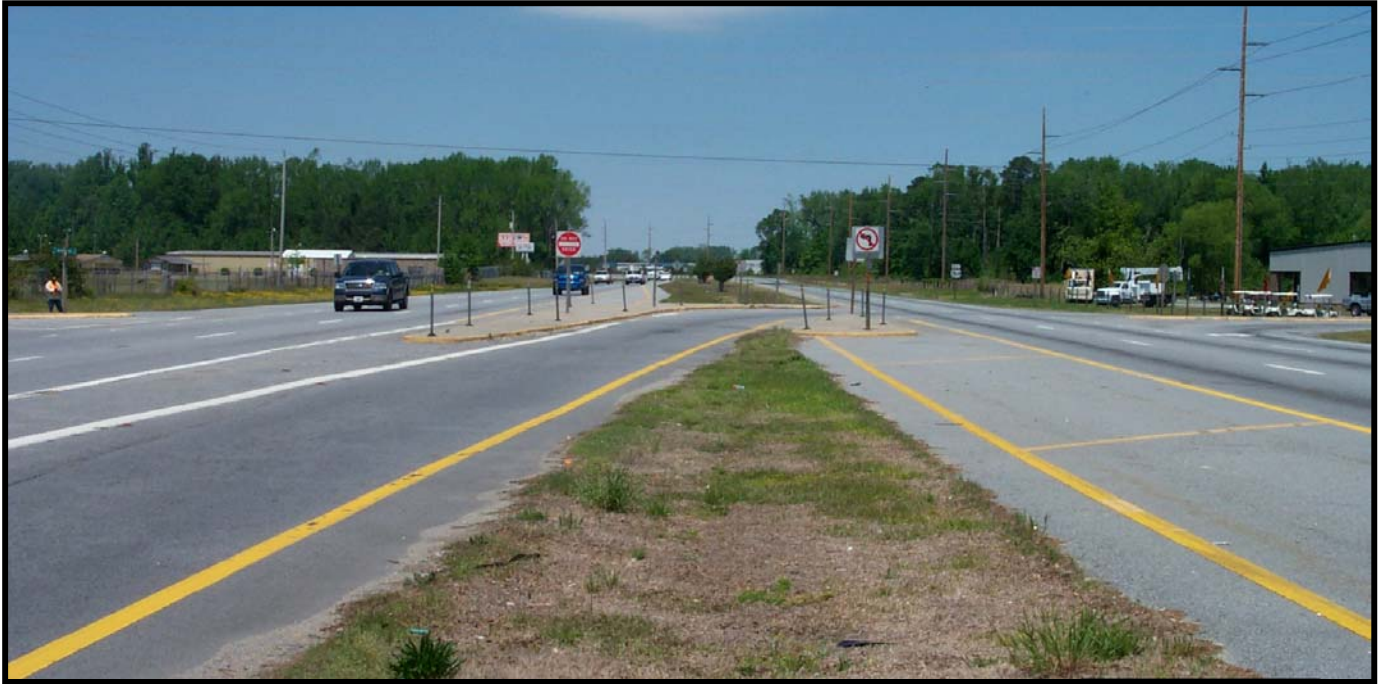
Looking north on US 264 – Greenville Blvd

Please see the attached *Treatment Site Location Photos*. Photos are provided for each leg of the treatment intersection. In addition, photos taken at the intersection of NC 33 at SR 1523/ SR 1534 and the intersection of US 264 at NC 33/ US 264A are provided.

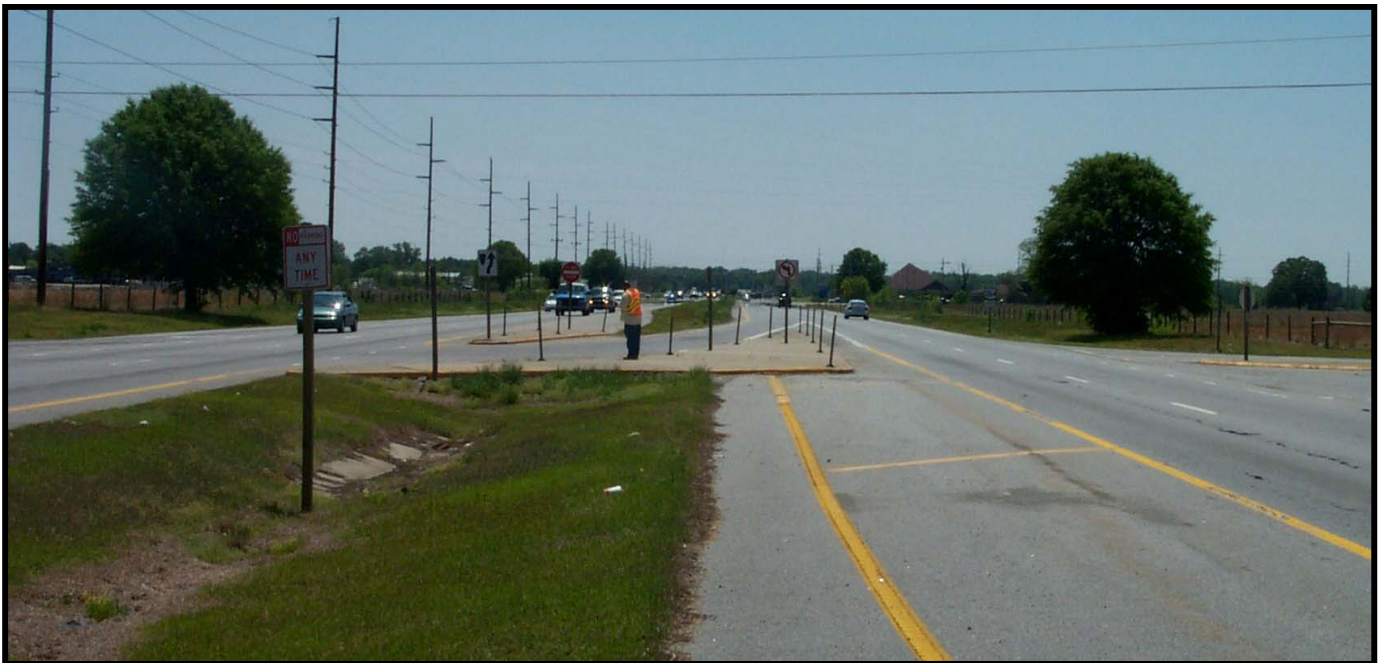
Looking south on US 264 – Greenville Blvd

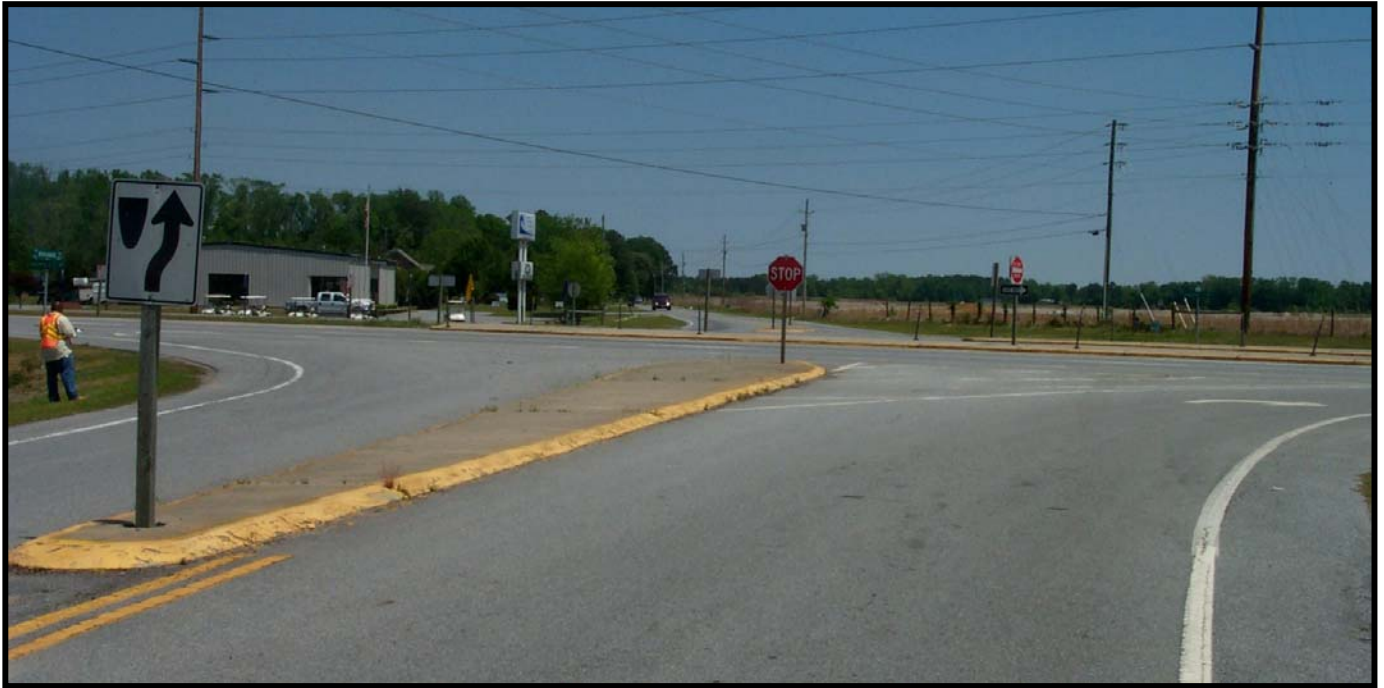
Looking east on SR 1523 – Whichard Road

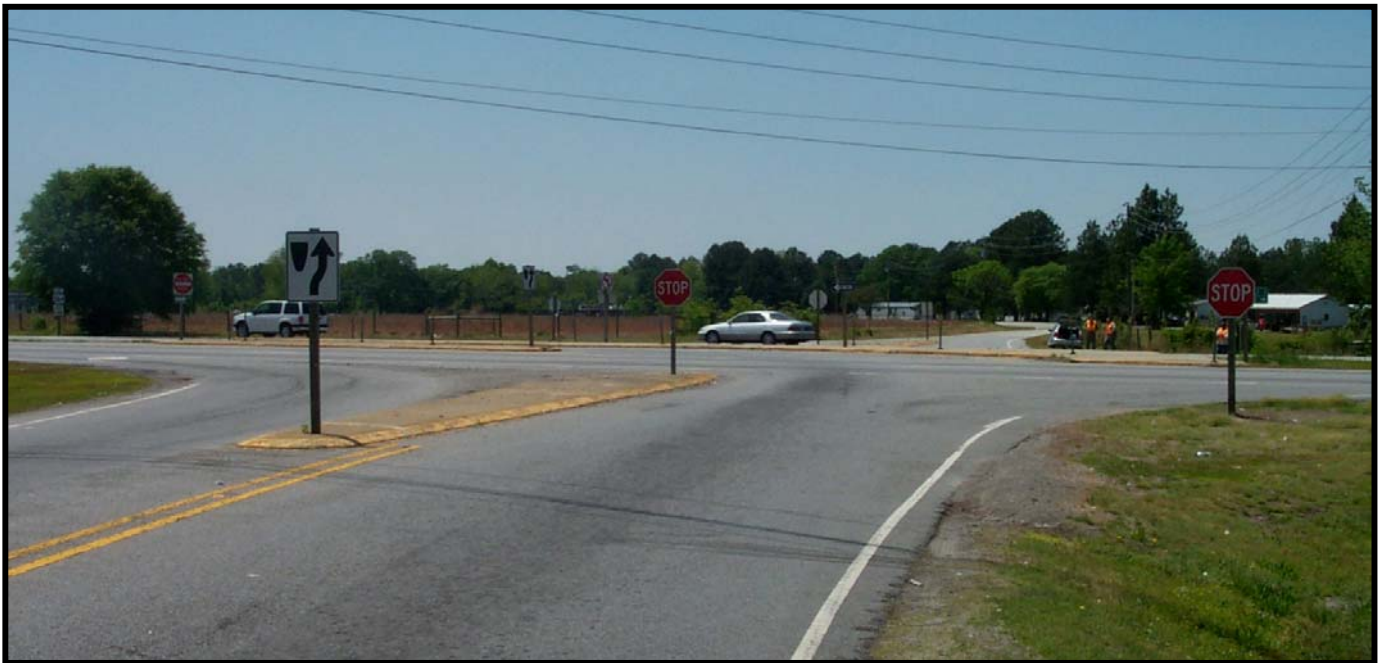
Looking west on SR 1523 – Whichard Road

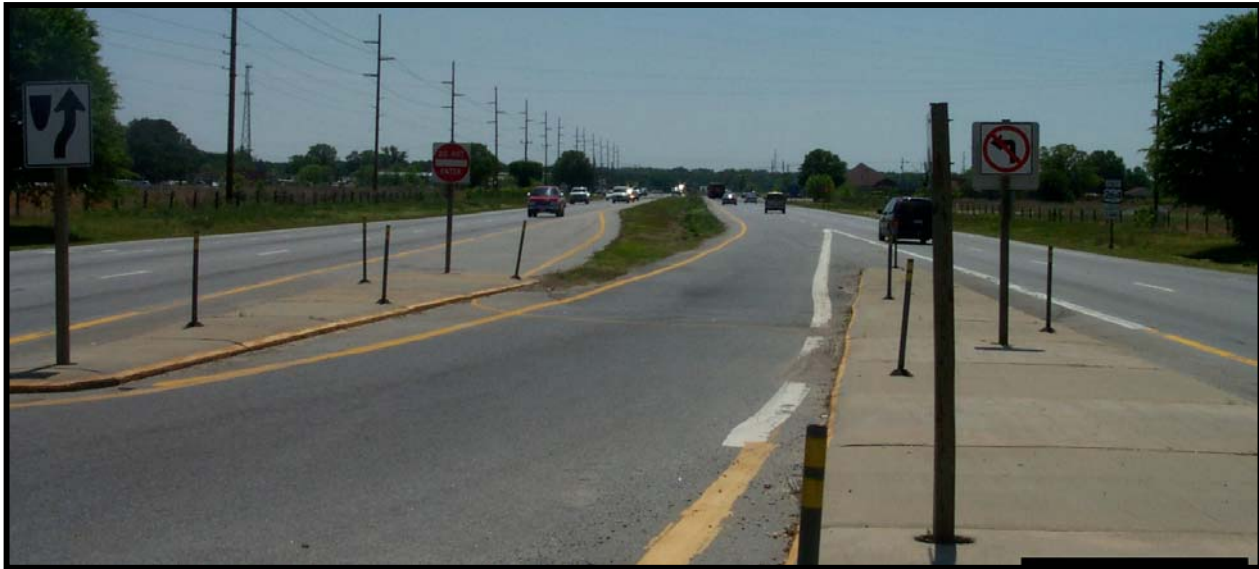
Additional photo of the directional crossover and lane constructed in the median,
Looking south towards the intersection of US 264 and NC 33.

surrounding intersections may be (at least partially) attributed to the installation of the directional crossover at the treatment location. The raised islands constructed in the crossover prevent through movements for both side street approaches and left-turn movements for the eastbound side street approach. Motorists wishing to make these movements need to find an alternative route (i.e. potential crash migration occurs). Therefore, the effect of the treatment on surrounding intersections must remain in consideration while assessing analysis of the Treatment Intersection.

The section of US 264-Greenville Blvd from 150 feet south SR 1523-Whichard Road to 150 feet north of US 264/ US 264A/ NC 33 was also analyzed. A full lane in the median of US 264-Greenville Blvd was constructed as part of the spot safety project from SR 1523-Whichard Road southward to the existing left-turn lane. While performing the site investigation, several “near-misses” (i.e. potential Rear-End or Sideswipe Crashes) occurred between southbound US 264 vehicles and vehicles merging from the crossover. However, analysis of crashes in this section revealed that the number of Rear-End Crashes between southbound vehicles only increased from four crashes in the before period to five crashes in the after period. Also, there were no reported Sideswipe, Same Direction Crashes within this section in either the before or after period.

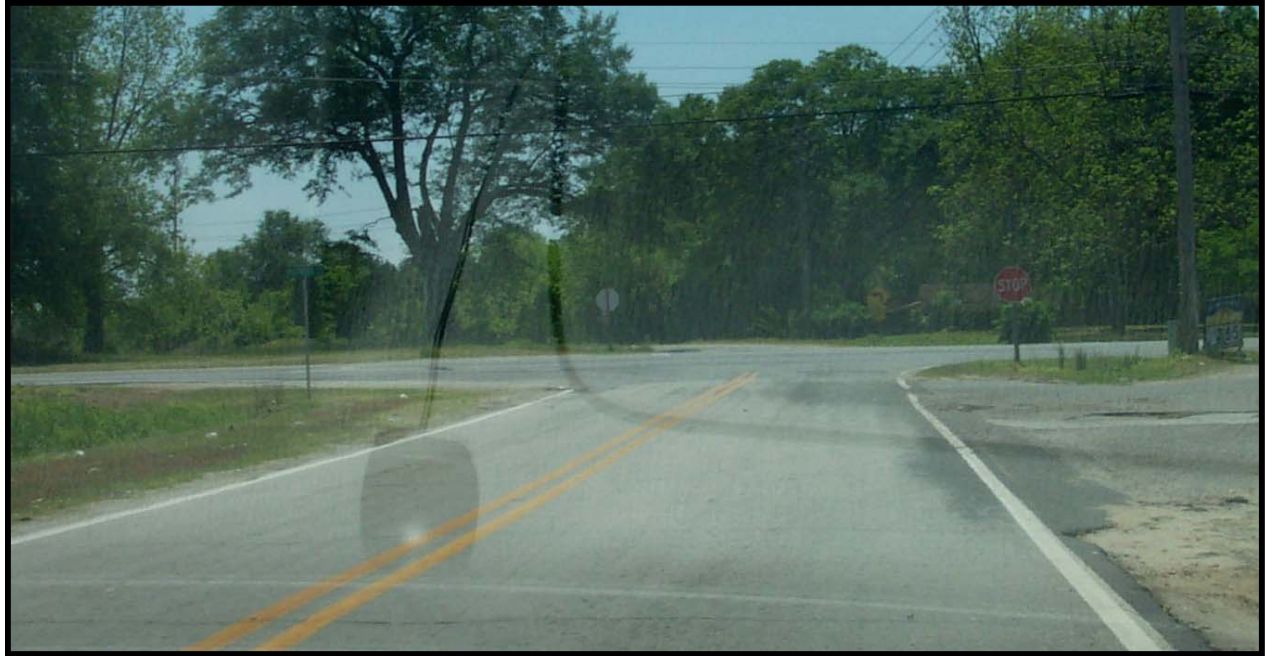
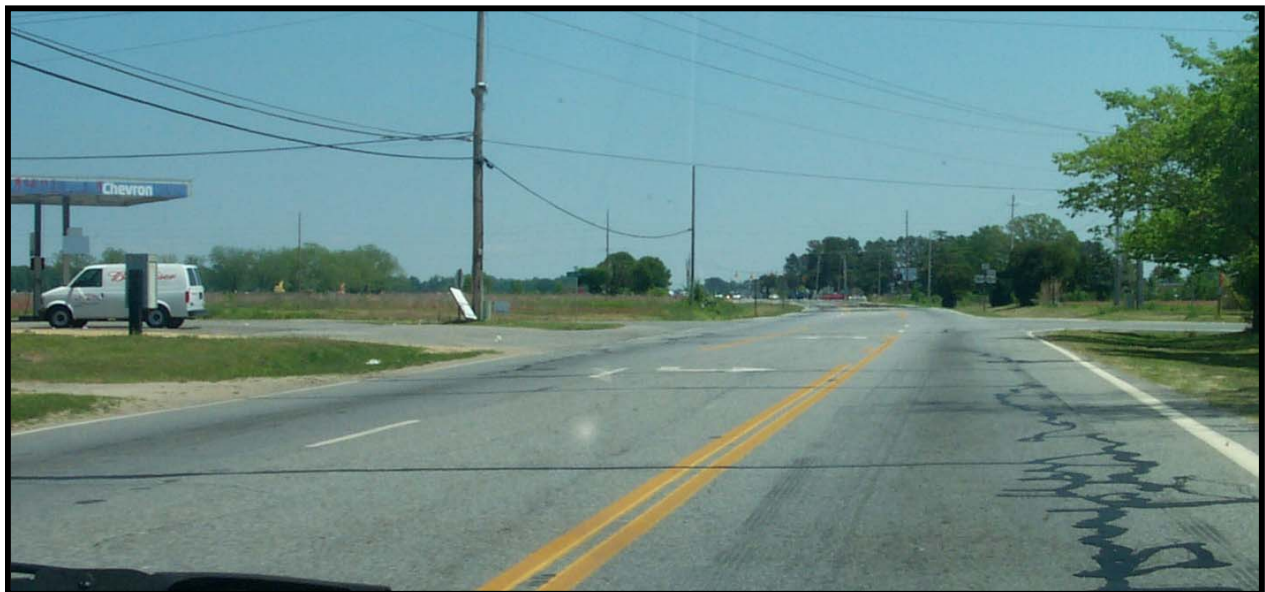
Photos taken at the intersection of NC 33 at SR 1523-Whichard Rd / SR 1534-Old Pactolus Rd.
Top: Driving southwest on SR 1523-Whichard Rd
Bottom: Driving east on NC 33

Because SR 1523-Whichard Road was used as a shortcut to westbound NC 33 prior to the directional crossover, crashes involving right-turn movements from westbound SR 1523-Whichard Road and left-turn movements onto eastbound SR 1523-Whichard Road from NC 33 were examined. The number of crashes involving these movements had the potential to decrease after the directional crossover cut off through movements on SR 1523-Whichard Road. The crash analysis revealed that the effects were minimal. Only two crashes in the before period and one crash in the after period involved vehicles making these maneuvers.

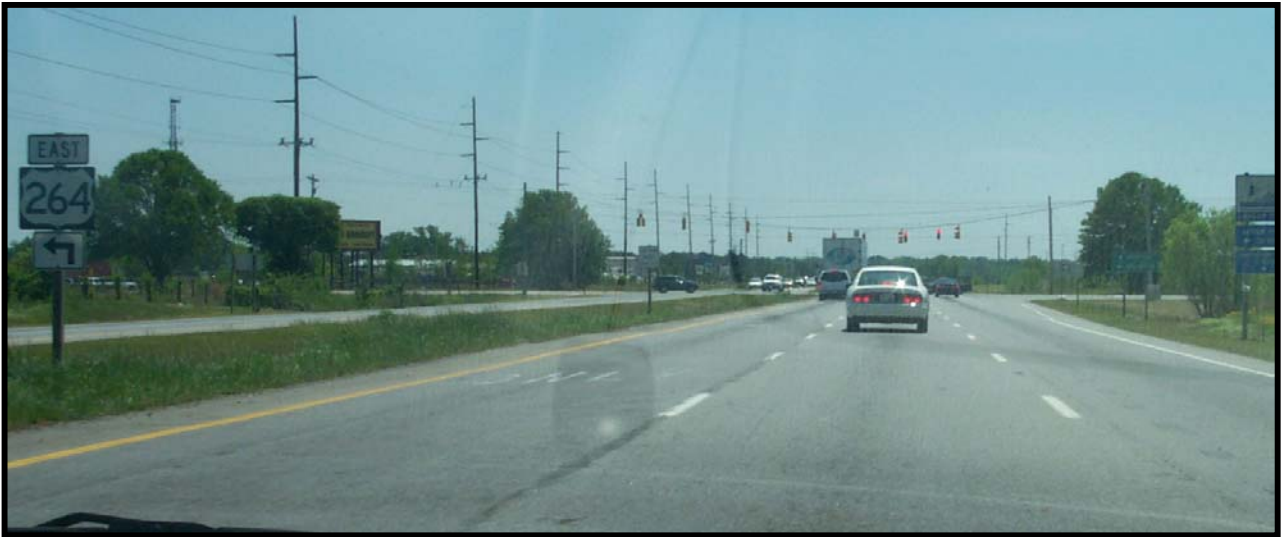
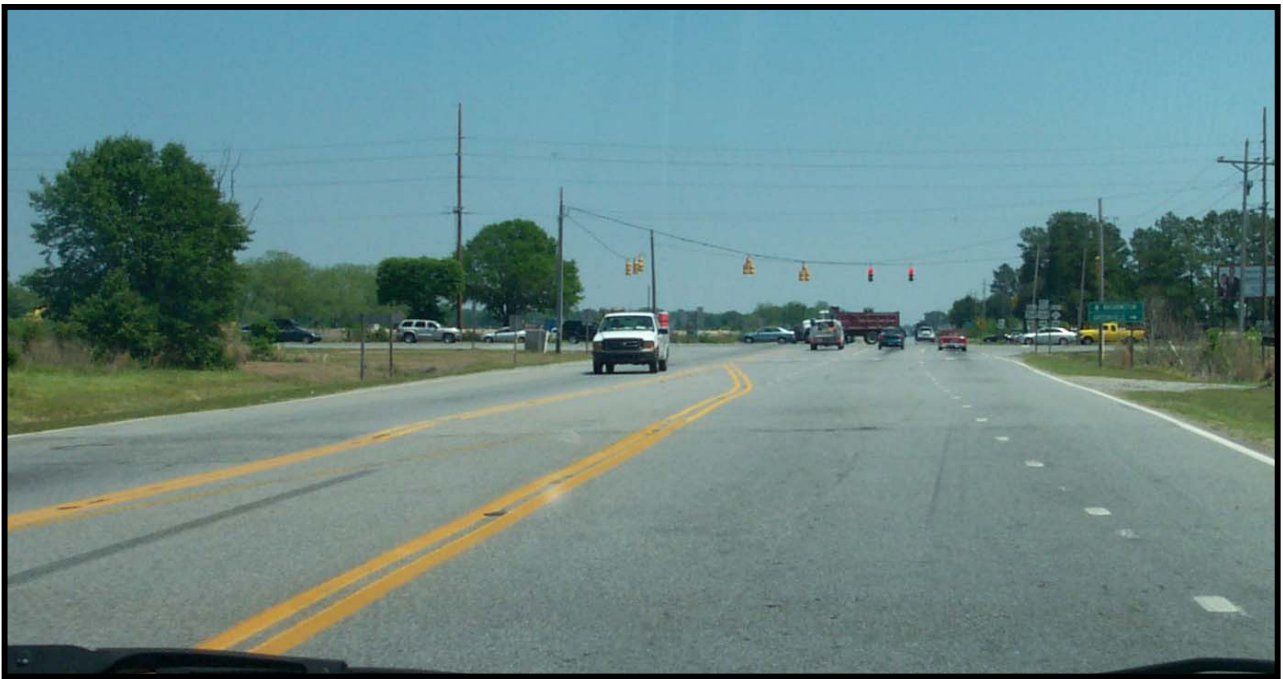
Photos taken at the intersection of US 264 at US 264A/ NC 33.
Top: Driving south on US 264
Bottom: Driving east on NC 33

The number of crashes involving left-turn movements from eastbound NC 33 onto northbound US 264-Greenville Blvd and right-turn movements from southbound US 264-Greenville Blvd onto westbound NC 33 were also examined. These crashes had the potential to increase because vehicles that previously used SR 1523-Whichard Road as a cut-through must now travel to the intersection of US 264 at NC 33 and US 264A. The number of crashes involving left-turn movements from eastbound NC 33 onto northbound US 264-Greenville Blvd increased from two crashes in the before period to nine crashes in the after period. There were no crashes involving right-turn movements from southbound US 264-Greenville Blvd. In addition, possible U-turn crashes from southbound vehicles on US 264-Greenville Blvd were examined. These crashes also had the potential to increase in the after period because of the movements prohibited at the treatment location. Possible U-turn crashes involved either Rear-End Crashes in the left-turn lane or involved conflict between left-turning vehicles and right turning vehicles on westbound US 264. There was no increase in the number of crashes involving U-turns from southbound US 264.

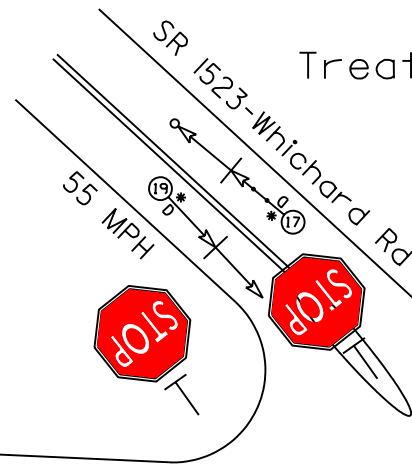
SS 02-94-216 Before

Treatment Site - TotalCrashes

Before Period

11/1/1993 - 2/28/1999

COLLISION DIAGRAM	
DIVISION:	AREA:
STUDY PERIOD: 11/1/93 - 2/28/99	
DISTANCE: Y-LINE = 150 ft	
ANALYSIS PREPARED BY: CLG	
ANALYSIS CHECKED BY:	
DIAGRAM PREPARED BY: CLG	
DIAGRAM REVIEWED BY:	
SCALE: NOT TO SCALE	
DATE: 5/1/2005	
LOG NUMBER: 20050207
